# Manhole Inspection Summary

Manhole # S19E\_\_003MH

Insp Date: **10/12/07 11:18 AM**

**Location** Address: **2242 LEXINGTON ST**

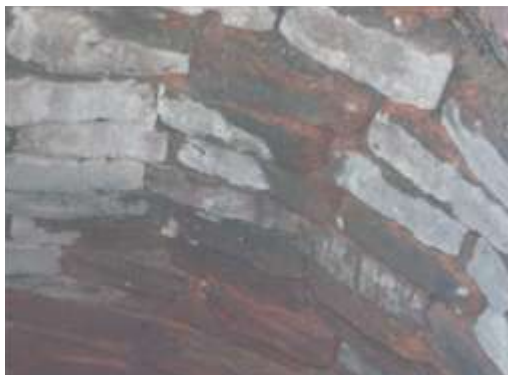
Defect 5

Infiltration: ☐ None ☐ Joint ☐ Cracks ☐ Mortar ☐ Roots ☒ **Wall**

CORBEL INFILTRATION

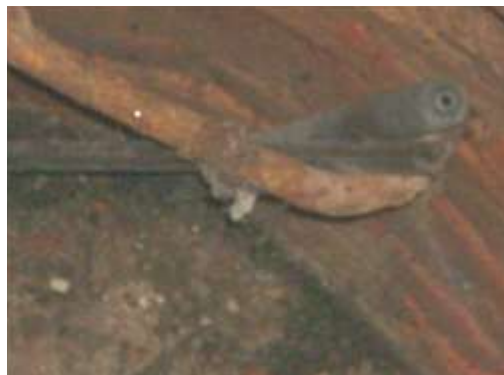
Defect 4

☒ **Evidence Of Surcharge** Depth: **2** (ft.) ☐ Active Surcharge Present

LITTLE BIT OF SURCHARGE  
EVIDENCE ON BOTTOM STEP

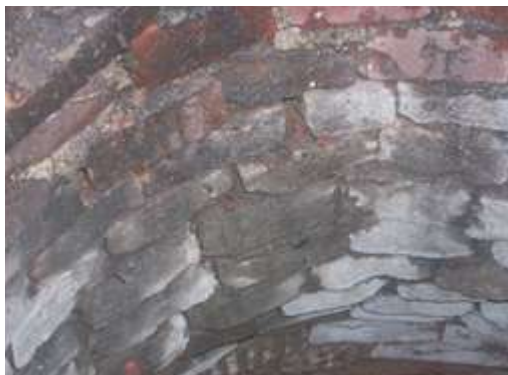
Defect 3

Condition: ☐ Sound ☐ Cracked ☐ Root Intrusion ☒ **Loose Brick** ☐ Deteriorated

LOOSE CORBEL BRICKS

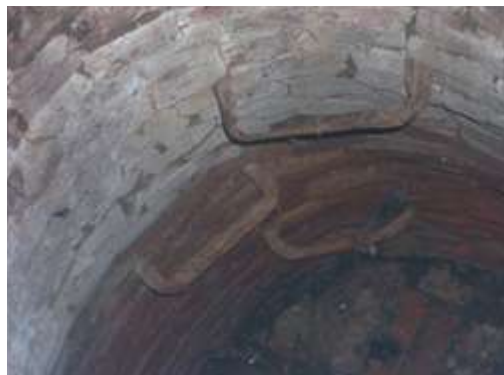
Defect 2

Count: **3** Missing: **0** ☒ **Corroded**

CORRODED STEPS

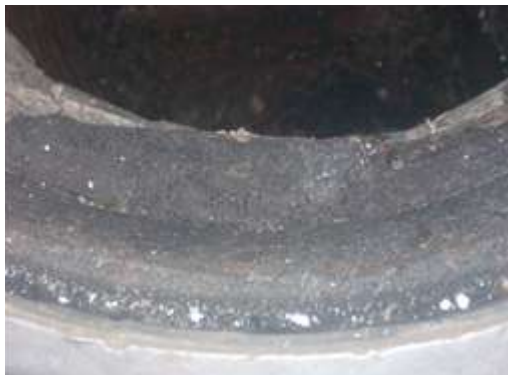
Defect 1

Offset: **1** (in.)

FRAME OFFSET

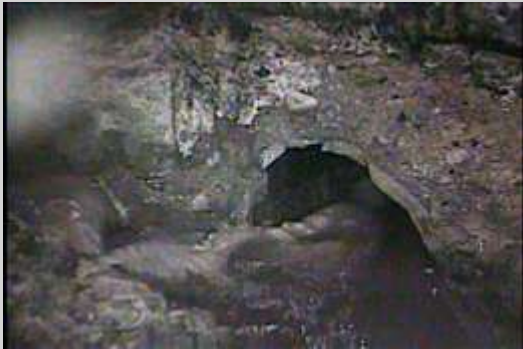
12 O'Clock Outflow

Pipe Height: **7.2** (in.) Rod and Bar (Angled)  
Pipe Material: **Clay** ☐ Pipe Lined  
Invert Depth: **8.59** (ft.) Flow Characteristics: **Slow**  
Deposits: ☐ None ☐ Mud ☒ **Sludge** ☐ Debris ☐ Grease  
Silt Depth: **4** (in.) Deposits Extent: **Medium**  
Infiltration: **None** Pipe Seal Cond: **Broken**

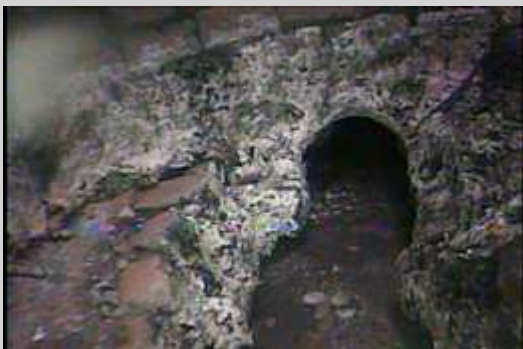
6 O'Clock Inflow

Pipe Height: **8.4** (in.) Rod and Bar (Angled)  
Pipe Material: **Clay** ☐ Pipe Lined  
Invert Depth: **8.38** (ft.) Flow Characteristics: **Slow**  
Deposits: ☐ None ☐ Mud ☒ **Sludge** ☒ **Debris** ☐ Grease  
Silt Depth: **2** (in.) Deposits Extent: **Light**  
Infiltration: **None** Pipe Seal Cond: **Sound**

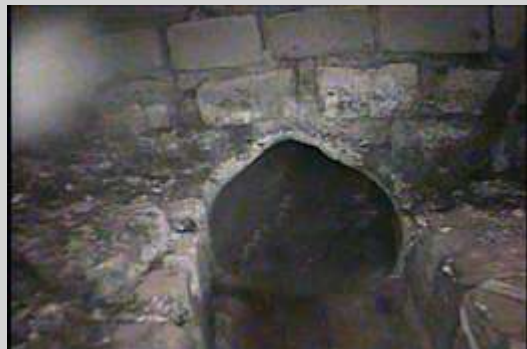
9 O'Clock Inflow

Infiltration: **None** Pipe Seal Cond: **Broken**
